**BLACKWOOD DISTRICT FIRE 18
BRIDGETOWN
27 DECEMBER 2003**

FIRE NARRATIVE

**Compiled by
Lachlan McCaw¹ and Rob Round-Turner²**

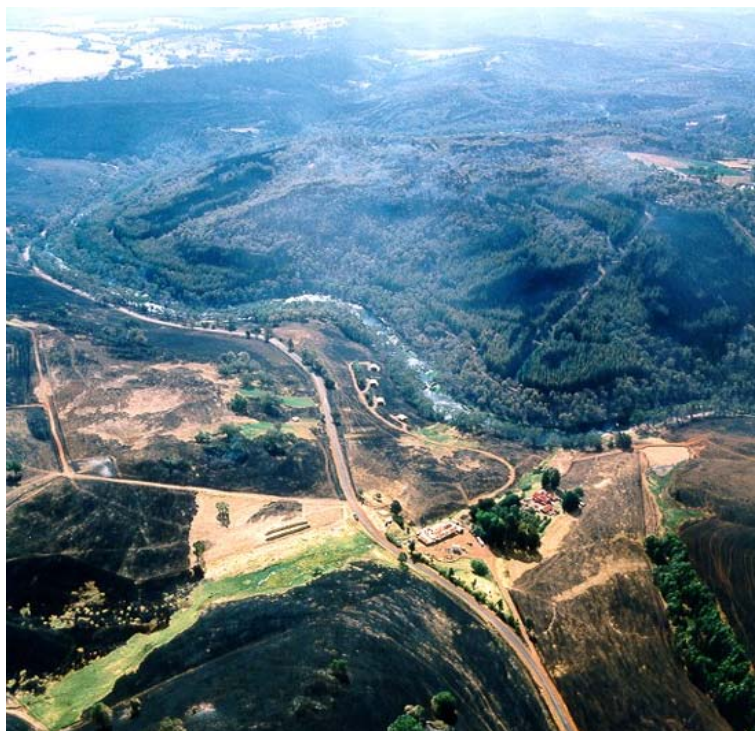
Rainfall at Bridgetown was 826 mm during the 12 month period to December 2003, closely matching the average of 823 mm. However the period from October to December was slightly drier than average (Anon. 2003). The month of December was dry with only 4 mm of rain recorded over four days from 18 to 21 December. At the time of the fire most dams retained good water levels, including some smaller dams that would normally dry out completely by the end of summer. Good seasonal conditions resulted in heavier than average growth of annual grasses. Dense swards of Wild Oats more than 1m tall were common in un-grazed areas. By the end of December, grasses in upland pastures and pine plantations were fully cured. Grass curing was incomplete in moist sites along the valley of the Blackwood River, including within and around the Bridgetown townsite. Swards of Kikuyu grass along drainage lines remained green and lush (Fig. 1).

Figure 1. View NW from the Brockman Highway across the Blackwood River in early January 2004. Low lying areas still carried green grass at the time of the fire, while upland pastures were fully cured. The extent of crown damage in pine plantation north of the river varies from minor crown scorch through to complete defoliation. Buildings are on Loc. 6361.

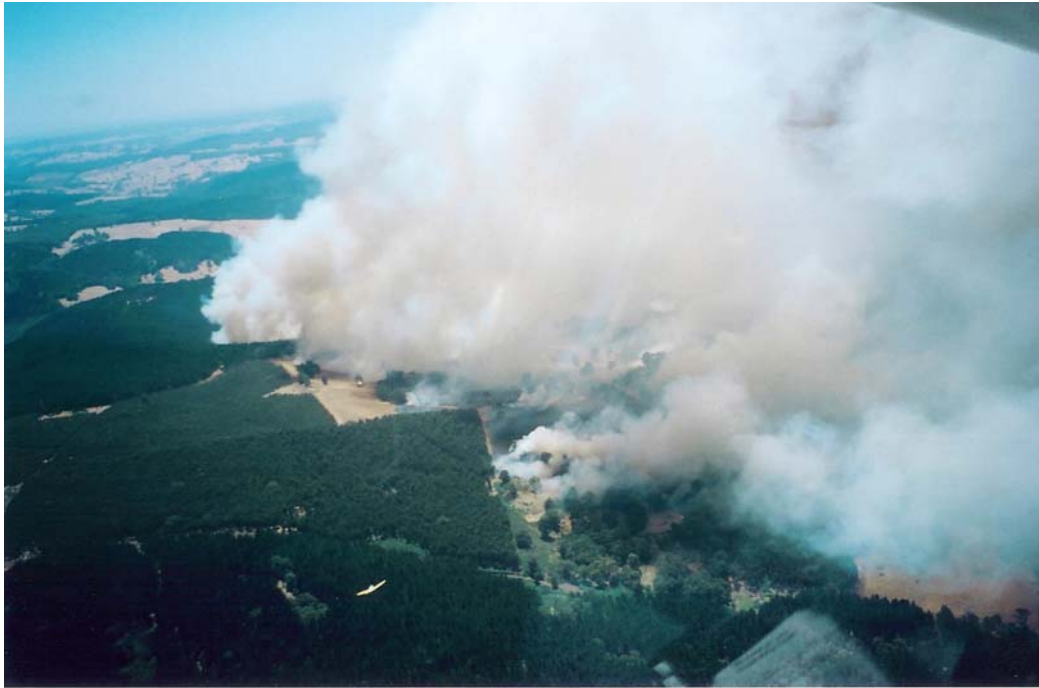
Figure 2. Photograph taken by the pilot of the CALM spotter aircraft looking north towards the origin of the fire at around 1200 hrs on 27 December. The large smoke plume appears to originate from fire in the Dalgapur pine plantation. In the foreground a number of spot fires are visible in private property (Locs. 20 and 886) adjoining Davies Rd.

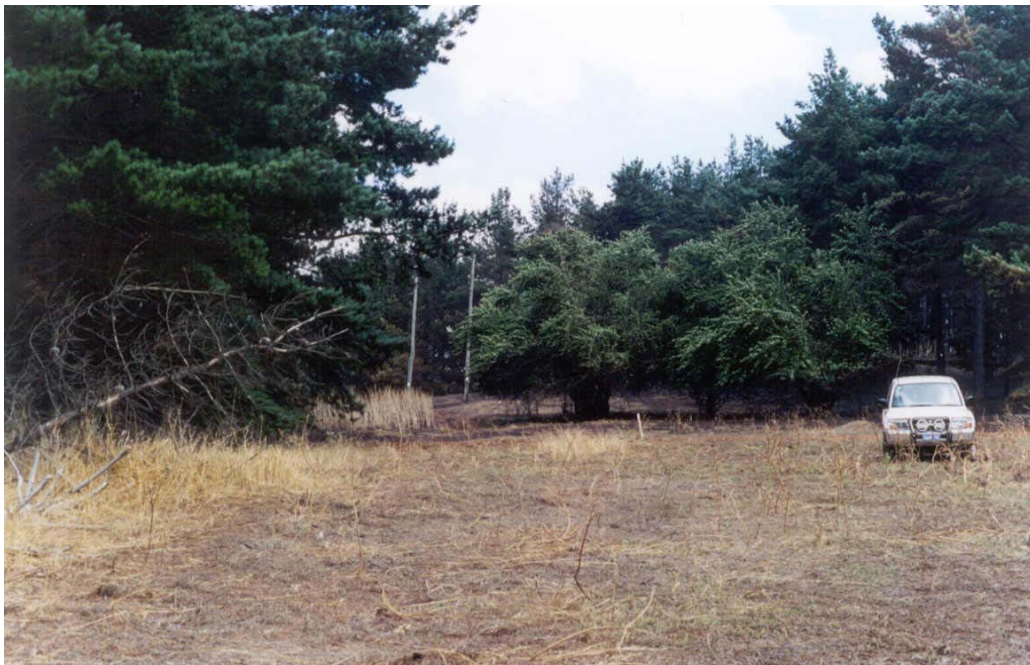
Figure 3. View southwards along the easement beneath the power line. The vehicle is parked immediately adjacent to Five Gates Rd. Two large Manchurian Pear trees can be seen growing on the easement directly beneath the power line. Spraying has restricted the growth of grass and weeds on the easement.

Investigations undertaken by FESA/CALM and the Energy Safety Division both concluded that the most probable cause of the fire was vegetation contacting the 12.7 kV power line that traverses the Dalgarpur pine plantation south of Five Gates Rd. Under the extreme weather conditions prevailing during the late morning on 27 December the fire ignited in sparse leaf litter and dead grass on the easement beneath the power line (Fig. 3). The easement had been sprayed to remove the grass for a width of at least 20 m beneath the power line and most of the grass residue was in a decomposed state that would have made it difficult to ignite (Fig 4). Despite the sparse fuels, the fire continued to spread into the plantation where it developed rapidly in a fuel bed of cured grass and pine needles (Fig. 5)

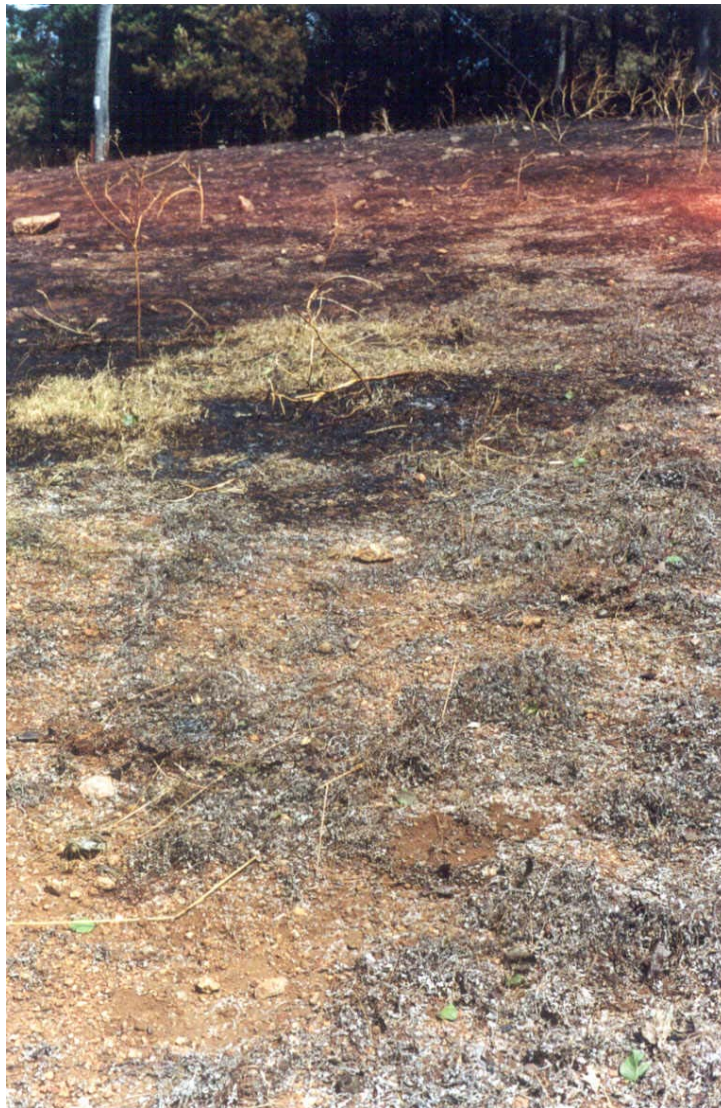
Figure 4. Section of easement south of the two pear trees showing the sparse condition of the ground fuels and patches of bare ground and unburnt grass residue.

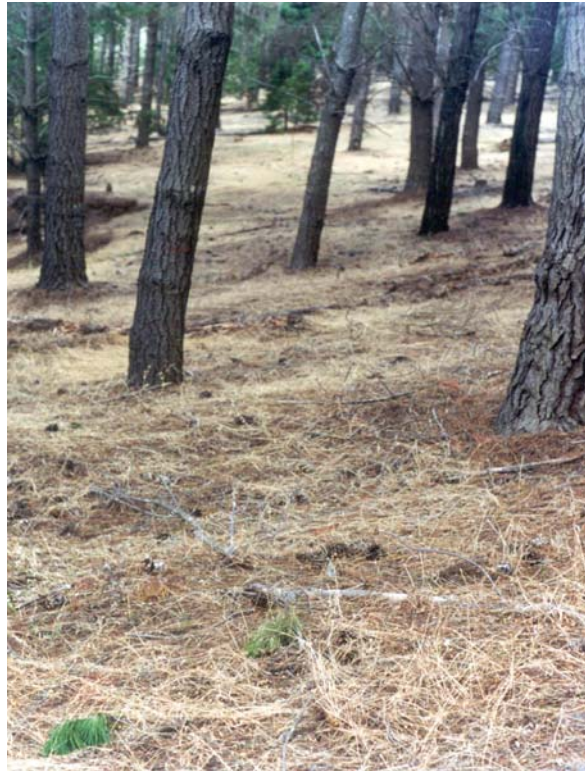
Figure 5. Fuel bed of pine needles and cured grass fuel in Dalgarpur pine plantation about 500 m east of the fire origin.

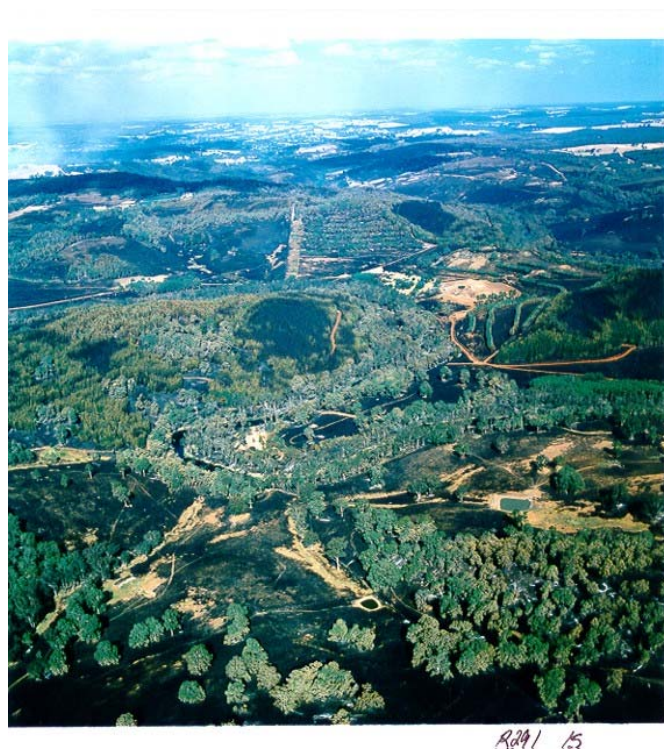
Figure 6. Looking ESE along the direction travelled by the head-fire. Longs Plantation and the Blackwood River are visible in the foreground. Much of the remnant native forest in paddocks and along the river has not been fully scorched by the fire, and there are unburnt patches where the pasture has not fully cured.

During the next two hours the head-fire spread through a mixture of pasture, remnant native forest, pine plantation and eucalypt woodlots (Figure 6). By 1500 hrs the fire had crossed the Blackwood River and spot fires were burning in pasture up to 1 km south-east of the river. The shape of the fire indicates that wind direction shifted westerly sometime shortly after 1500 hrs driving the fire eastwards towards State Forest in the Glenlynn block. This change in wind direction was not evident in the observations from the Bridgetown AWS. At about 1600 hrs a second major fire run crossed the Blackwood River about 2 km north-east of where the head-fire had crossed an hour earlier.

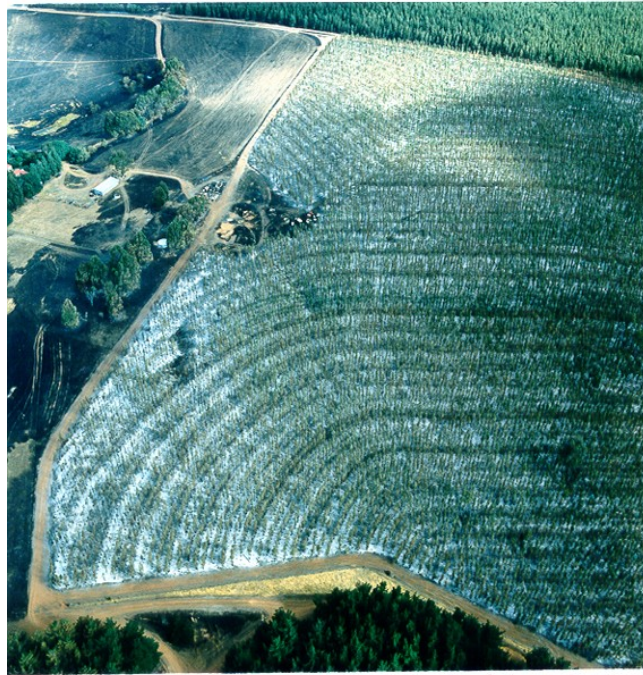
Figure 7. View to the south-east across Loc. 2 showing burnt second rotation Bluegum plantation in the foreground, and unburnt Bluegum plantation behind.

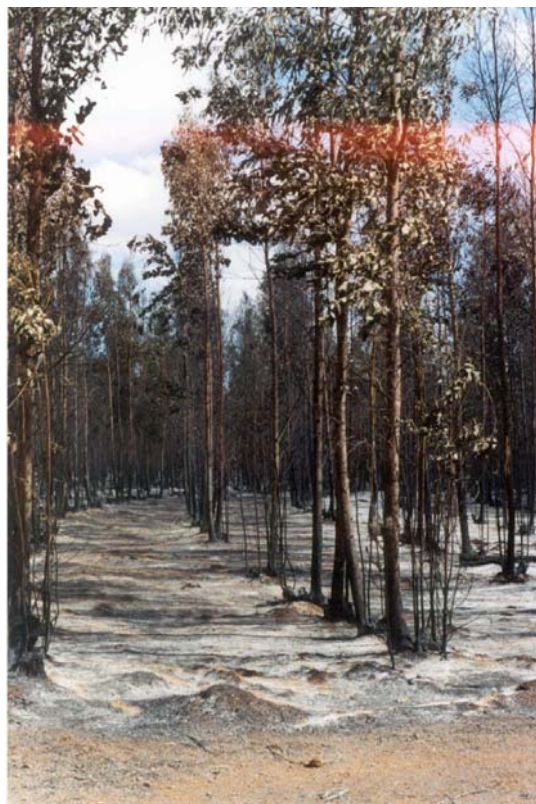
Figure 8. Looking into burnt second rotation Bluegum plantation on Loc. 2 showing coppice stems re-grown from harvested stumps, and white ash resulting from consumption of thinning slash on the ground.
